existing condition survey
main building
volume 1
appendix A

ELLIS ISLAND

EXISTING CONDITION SURVEY
MAIN BUILDING

Beyer Blinder Belle/
Anderson Notter Finegold

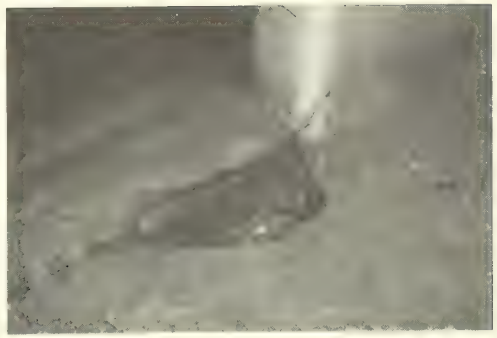
DESTROYED

0-30% intact. Material is completely missing or is destroyed beyond practical retrieval.

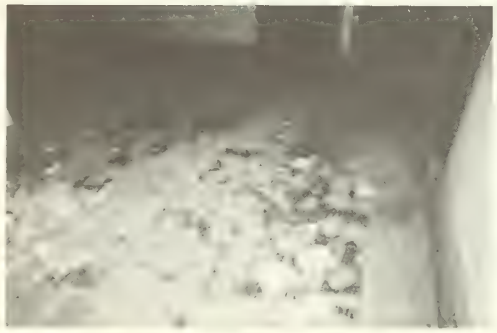
POOR

30-60% intact. Significant number of squares are missing, broken, buckling, loose, no longer adhered.

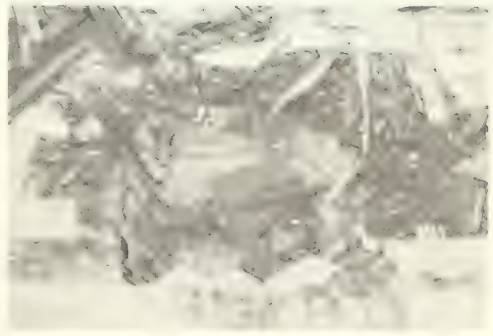
DESTROYED

0-30% intact. Material is completely missing or is destroyed beyond practical retrieval.

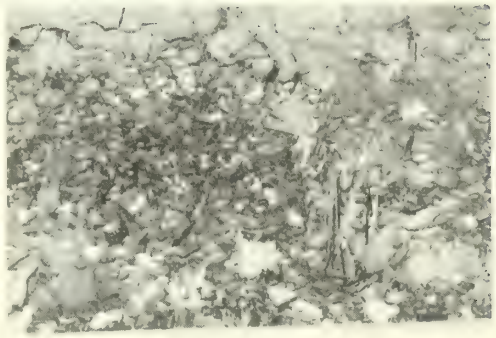
DESTROYED

0-30% intact. Material is completely missing or is destroyed beyond practical retrieval.

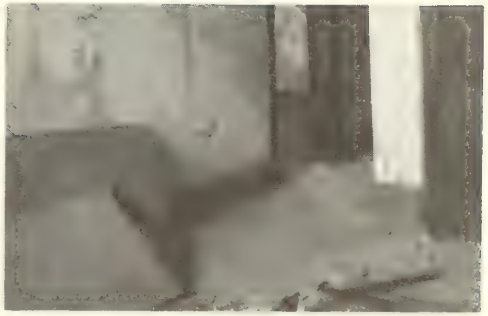
FAIR

75-90% intact. Separated from wall in limited areas. Some deterioration in localized areas (generally along window).

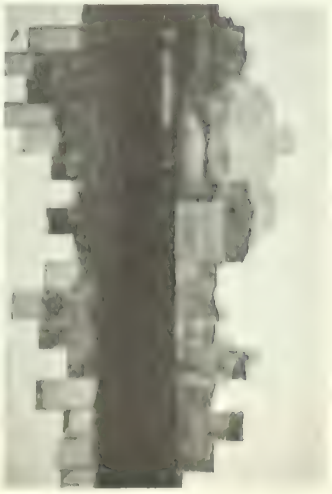
DESTROYED

0-30% intact. Material is completely missing or is destroyed beyond practical retrieval.

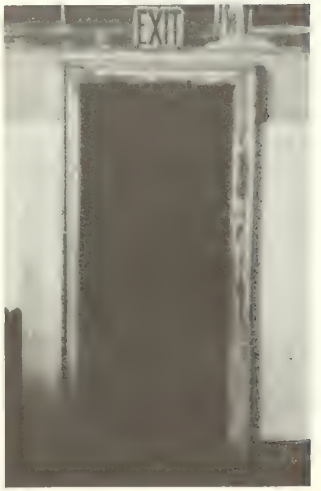
DESTROYED

Door is missing or is destroyed beyond practical retrieval.

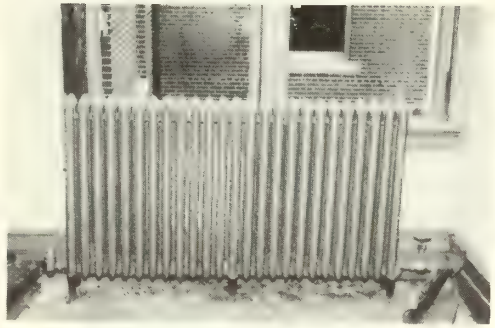
GOOD

Minor surface corrosion, some paint peeling.

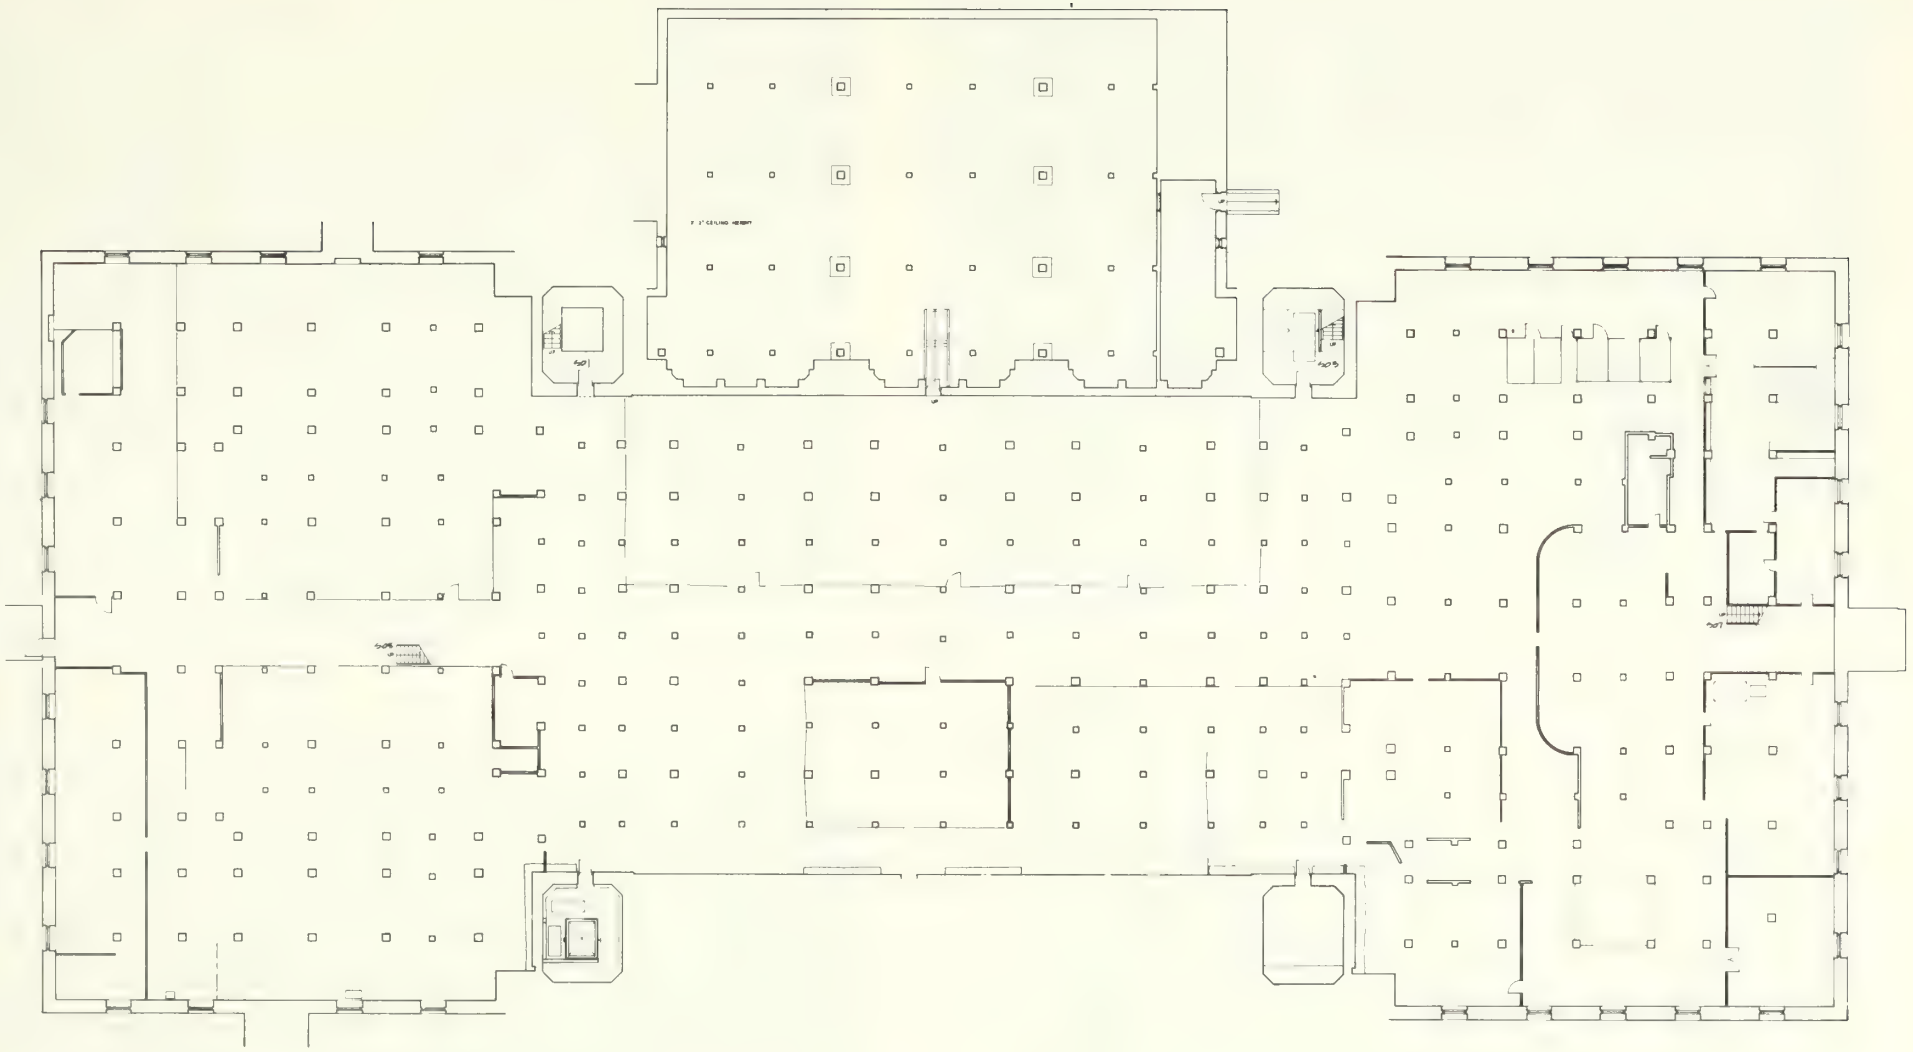
BASEMENT PLAN

The walls, floor & ceiling appear to be in fair condition.

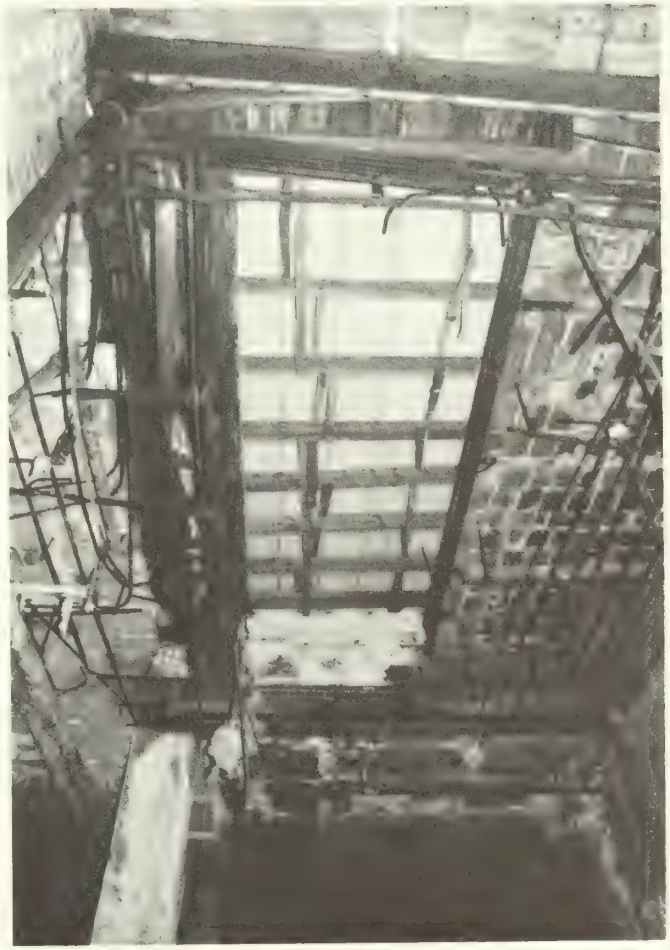
PHOTOGRAPHS: (1) View northeast (2) Skylight + ceiling, view east ROOM NO. 113

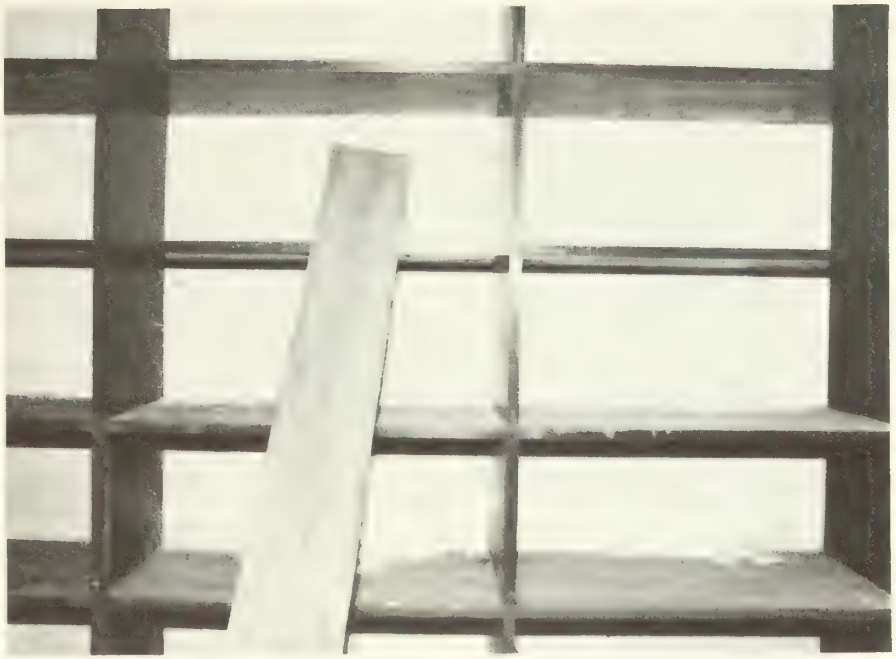
ROOM NO. 114A

PHOTOGRAPHS: (1) South wall

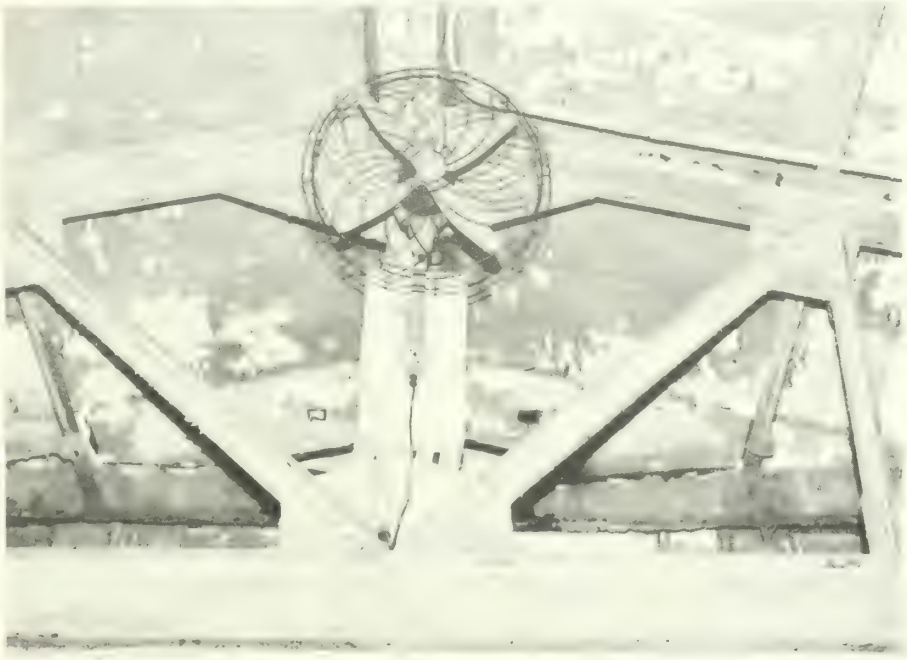
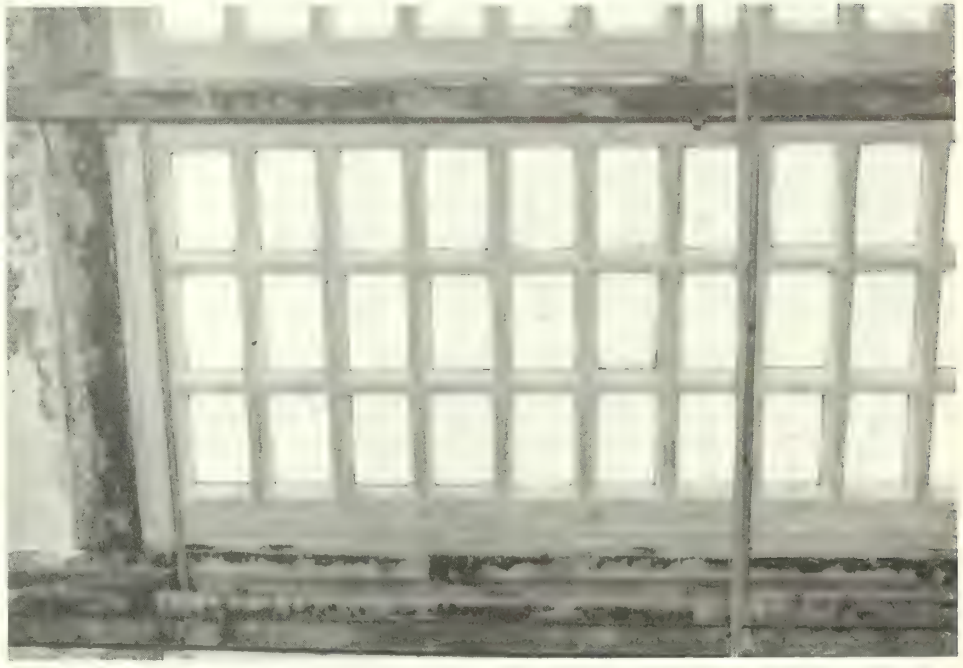
ROOM NO. Railroad Ticket Office (121)

PHOTOGRAPHS: 5. Truss & fan,detail. 6. Skylight.

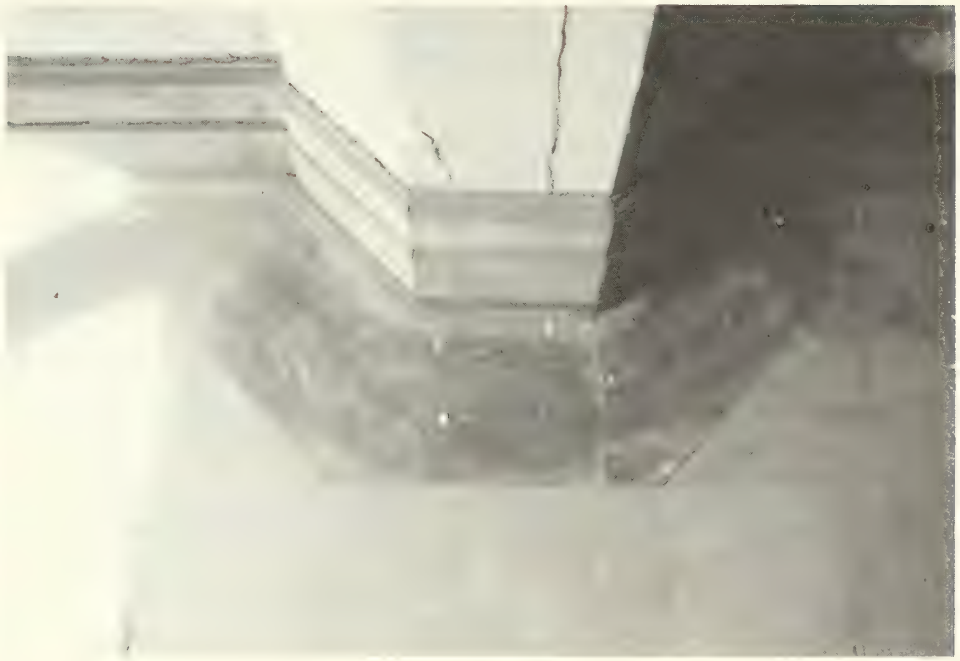
PHOTOGRAPHS: (1) View South (2) Column base ROOM NO. 153

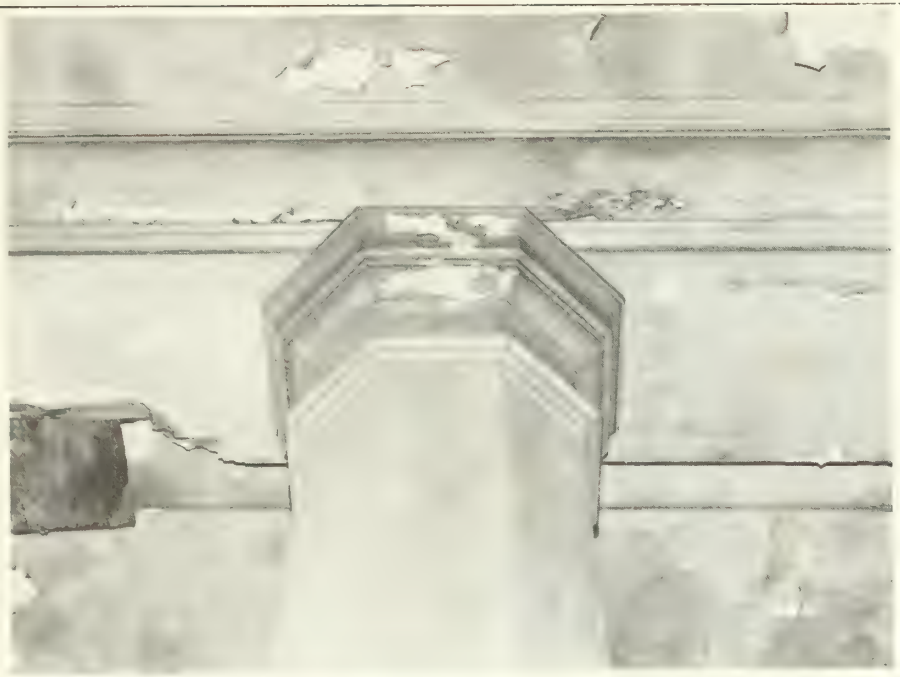
PHOTOGRAPHS: (1) Column capital (2) Cove ceiling (3) View northeast (4) View Southwest ROOM NO. 155

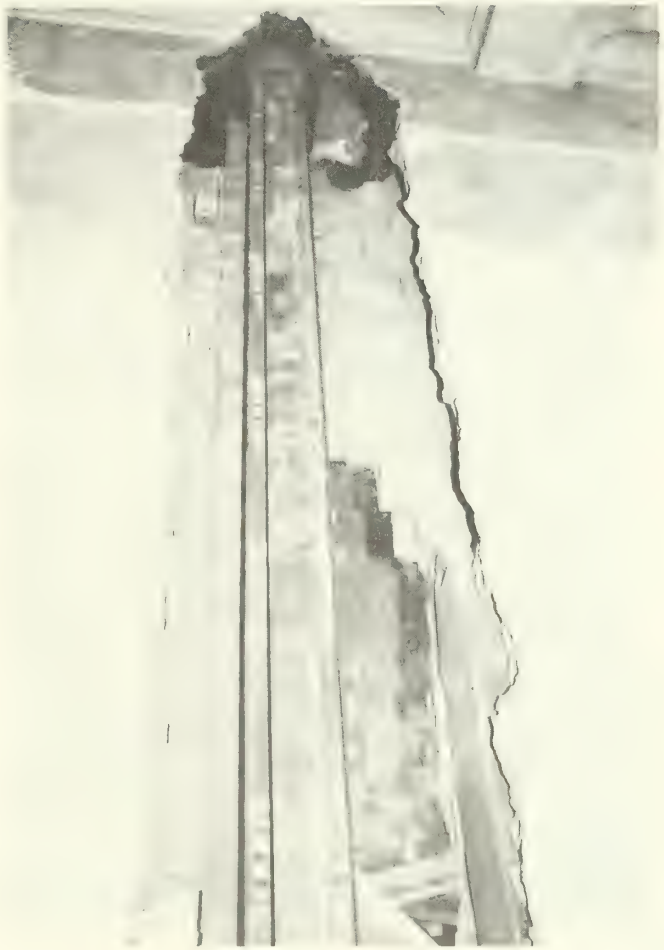
PHOTOGRAPHS: (1) Column, north wall (2) View southeast (3) View southwest ROOM NO. 160

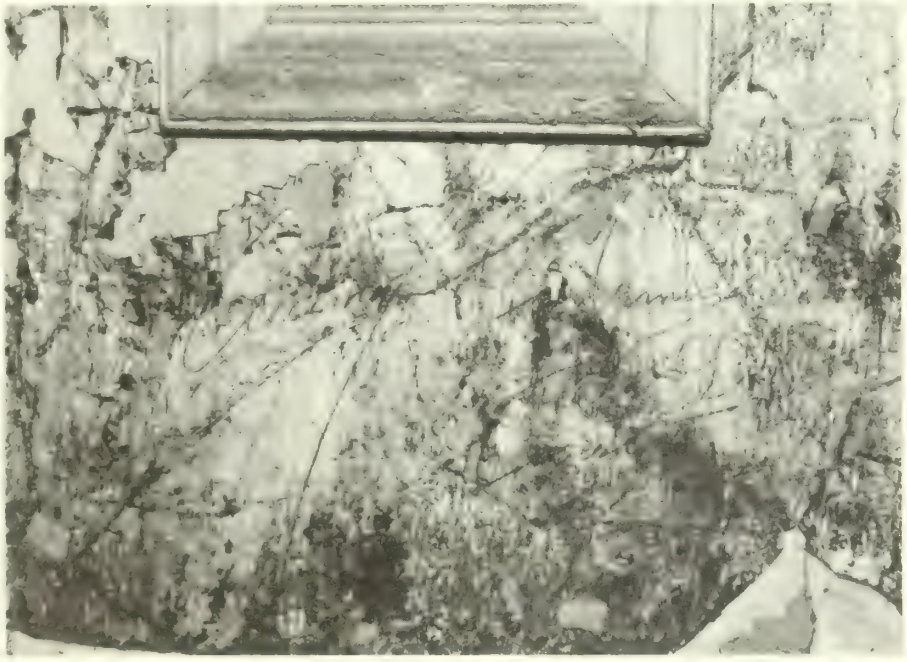
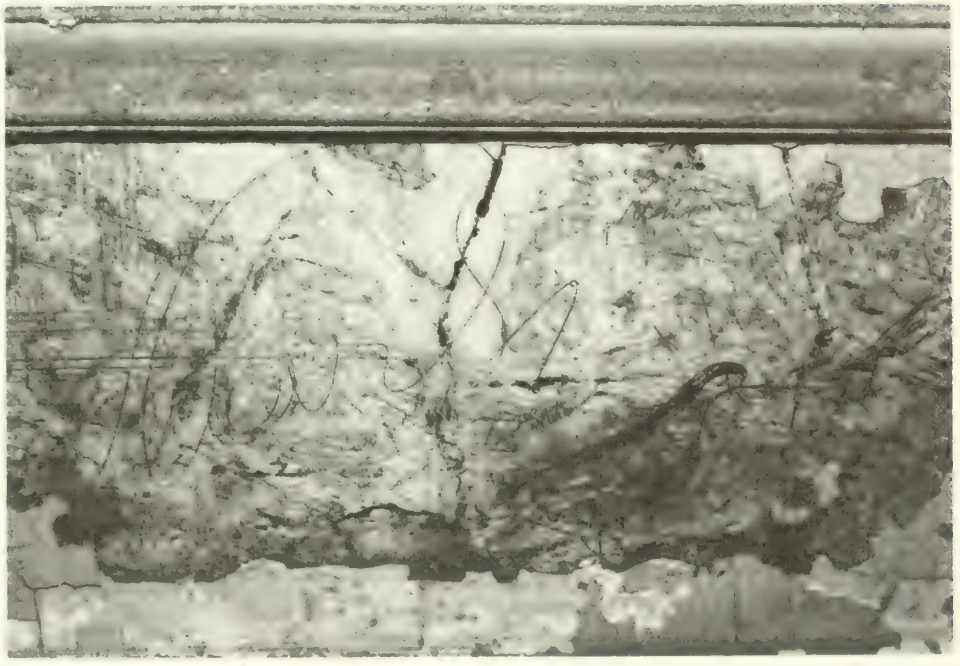
PHOTOGRAPHS: (1) View southwest (2) View north (3) West wall with graffiti exposed (4) Graffiti: 1901 date ROOM NO. 219

PHOTOGRAPHS: (5) Graffiti (6) Graffiti ROOM NO. 219

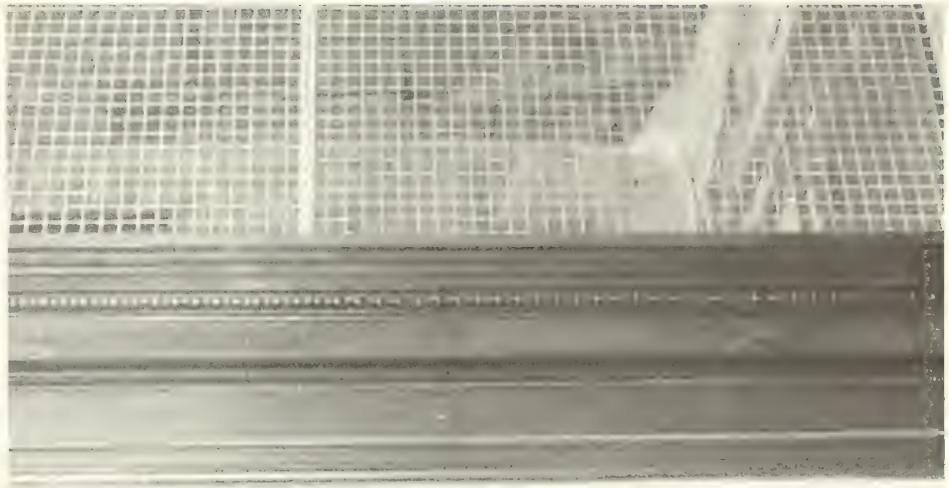
ROOM NO. 220, 220A

PHOTOGRAPHS: Rm. 220: ① View north ② View South ③ Mosaic + terrazzo Floor ④ Entablature, Southwall **ROOM NO.** 220, 220A

PHOTOGRAPHS: (1) View west, Rm. 220A

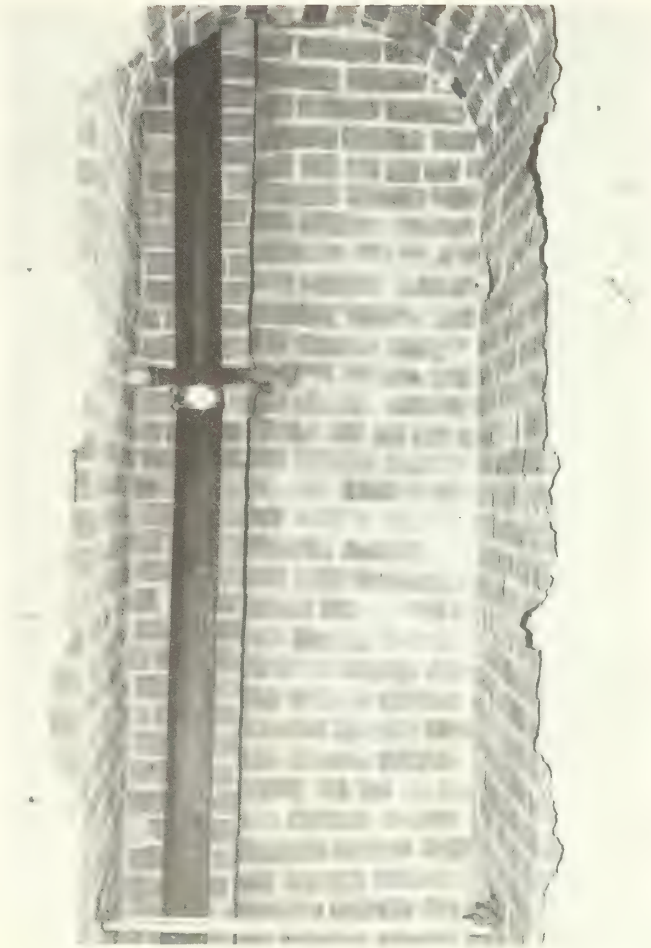
PHOTOGRAPHS: 7. Exposed shaft, north wall 8. Ceiling under balcony **ROOM NO.** Registry Room 231

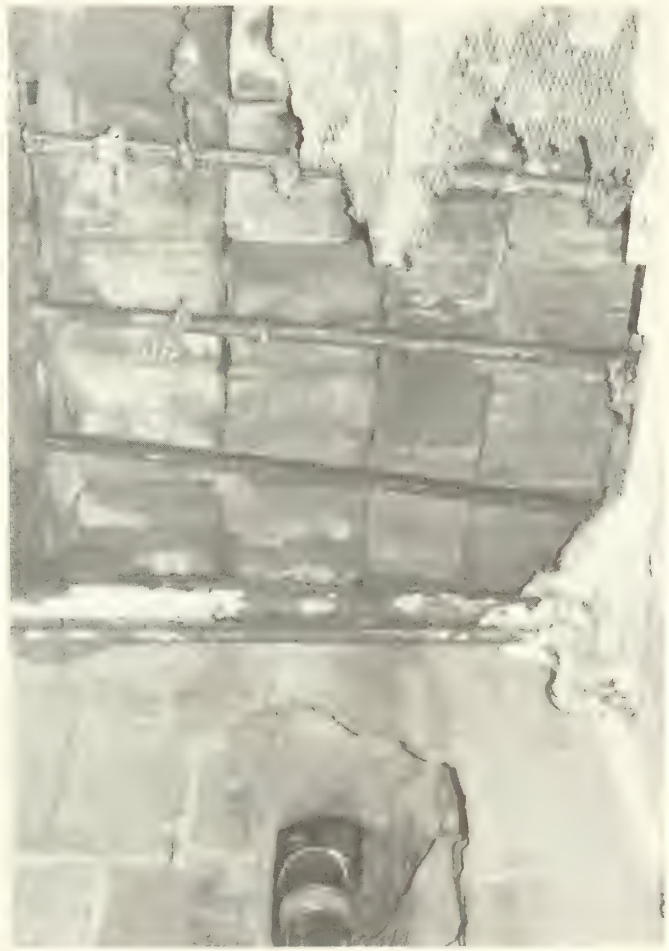
PHOTOGRAPHS: (1) View southwest (2) View northwest (3) Ceiling, southwest corner ROOM NO. 252

PHOTOGRAPHS: (4) Cove ceiling ROOM NO. 252

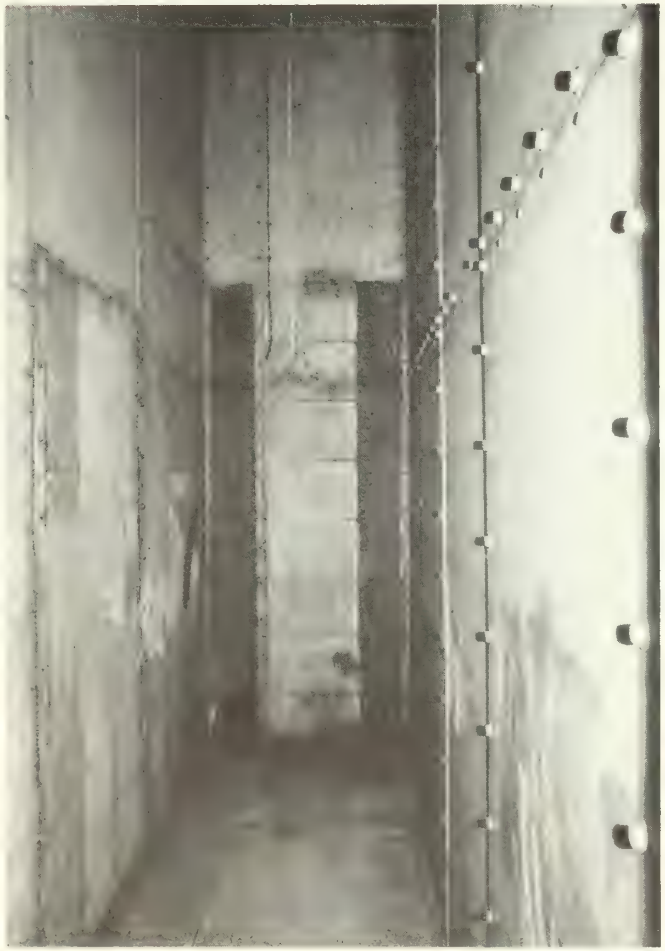
ROOM NO. 260A

PHOTOGRAPHS: (1) View west

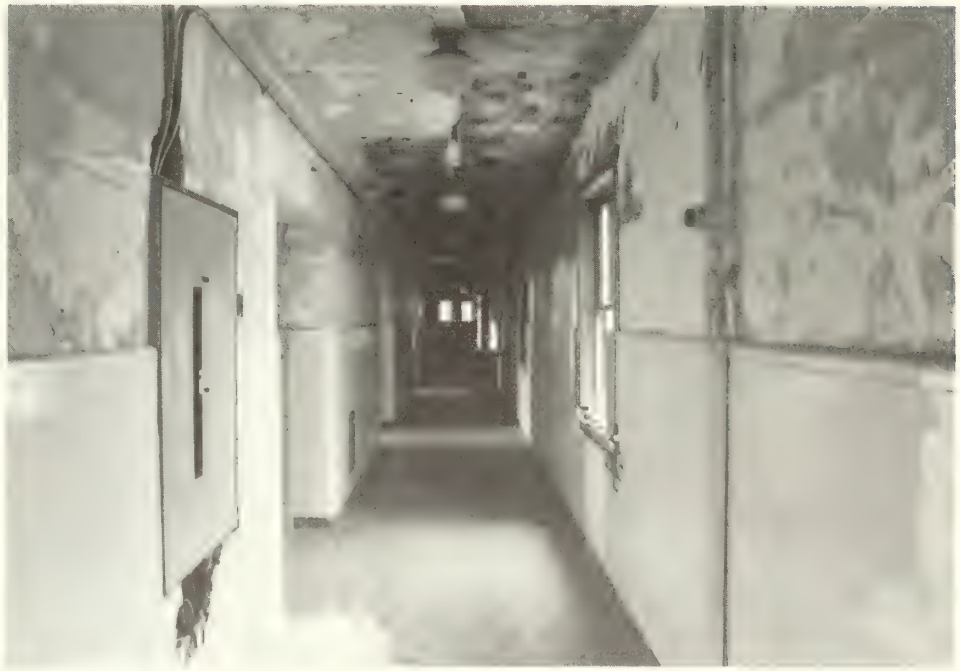
PHOTOGRAPHS: (1) Wood railing, west end of hall (2) View west ROOM NO. H209

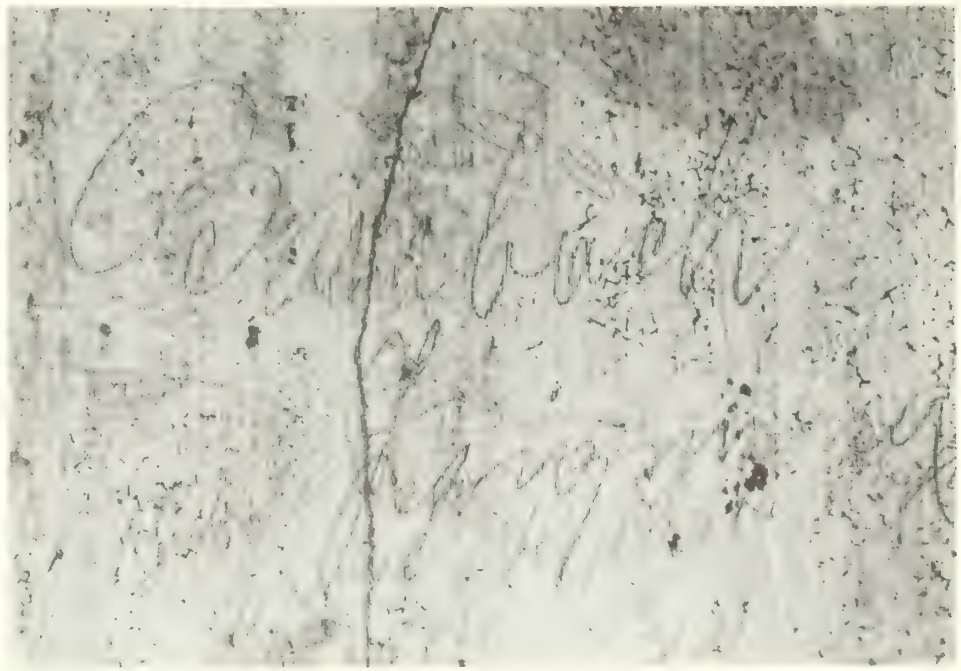
PHOTOGRAPHS: (1) View east (2) Graffition door ROOM NO. 309

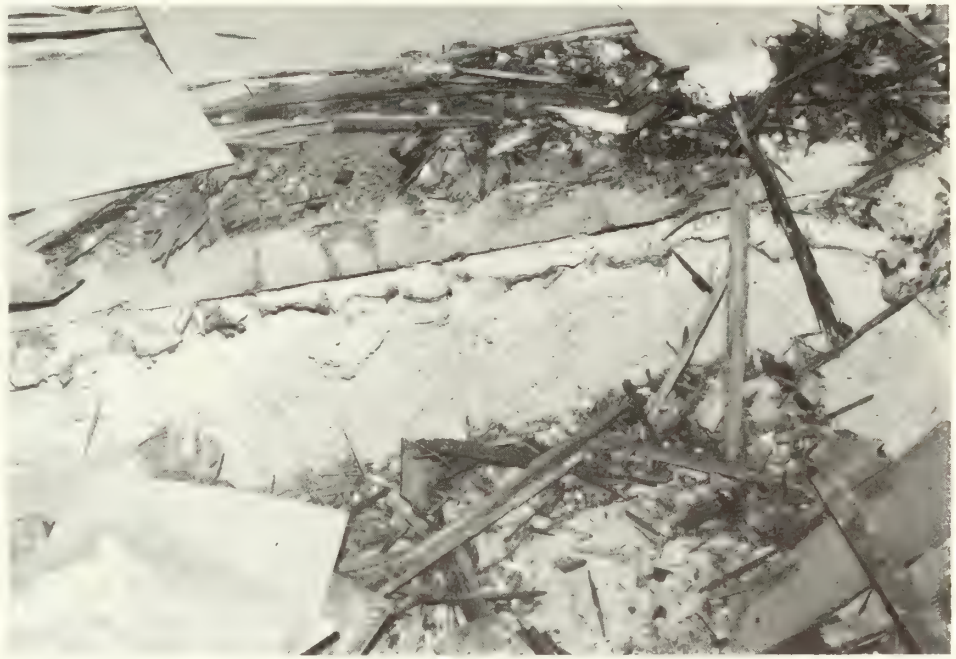
PHOTOGRAPHS: (1) View south (2) Hole in floor ROOM NO. 359

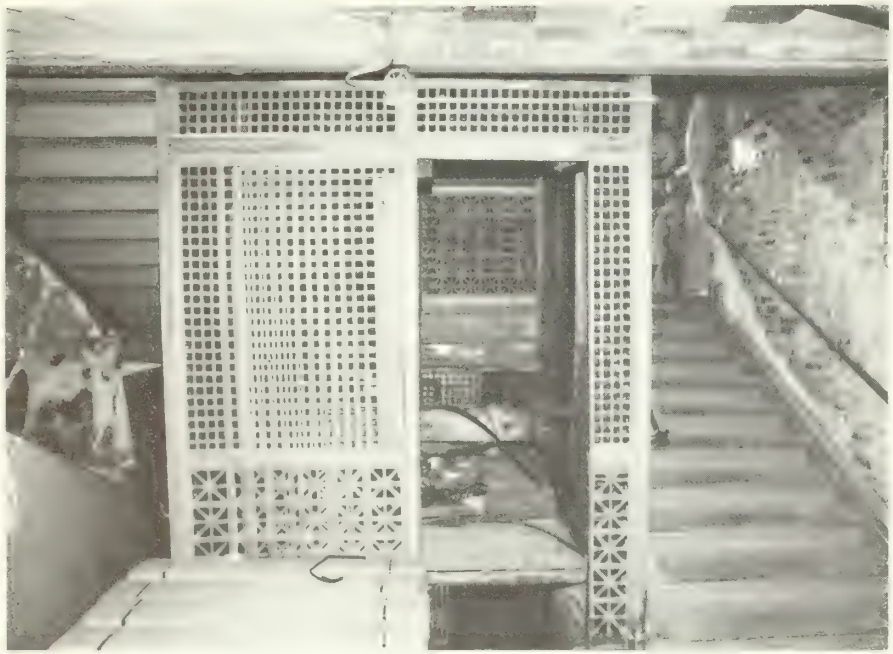
PHOTOGRAPHS: 1. First floor landing, view south 2. Second floor landing, view south **ROOM NO.** S02
